3.0 PHYSICAL ANALYSIS

3.1 GENERAL DESCRIPTION OF GOAT ISLAND

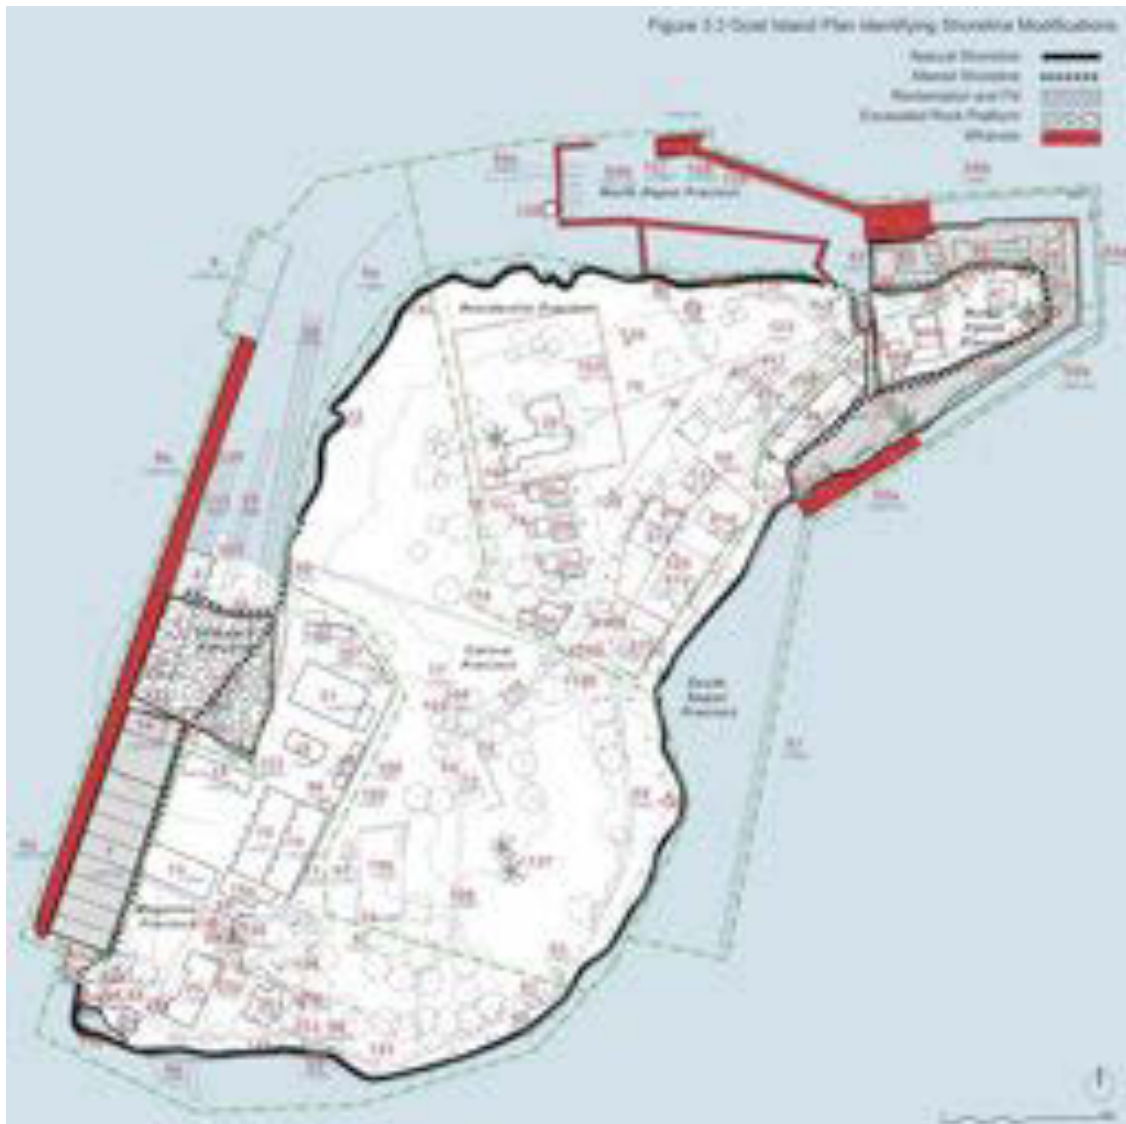
Figure 3.3 Plan of Goat Island showing the extent of modified and non-modified shoreline, areas of fill and excavation around the shoreline and the wharfs. This plan indicates that most of the shoreline remains intact or with only very minor modifications to the natural edge. This plan is based on the 2007 aerial photograph and it is noted that sections of wharfs 4a, 4b, 5 and 51 and wharves 52b, 54c, 55a and 55b have collapsed and been removed.

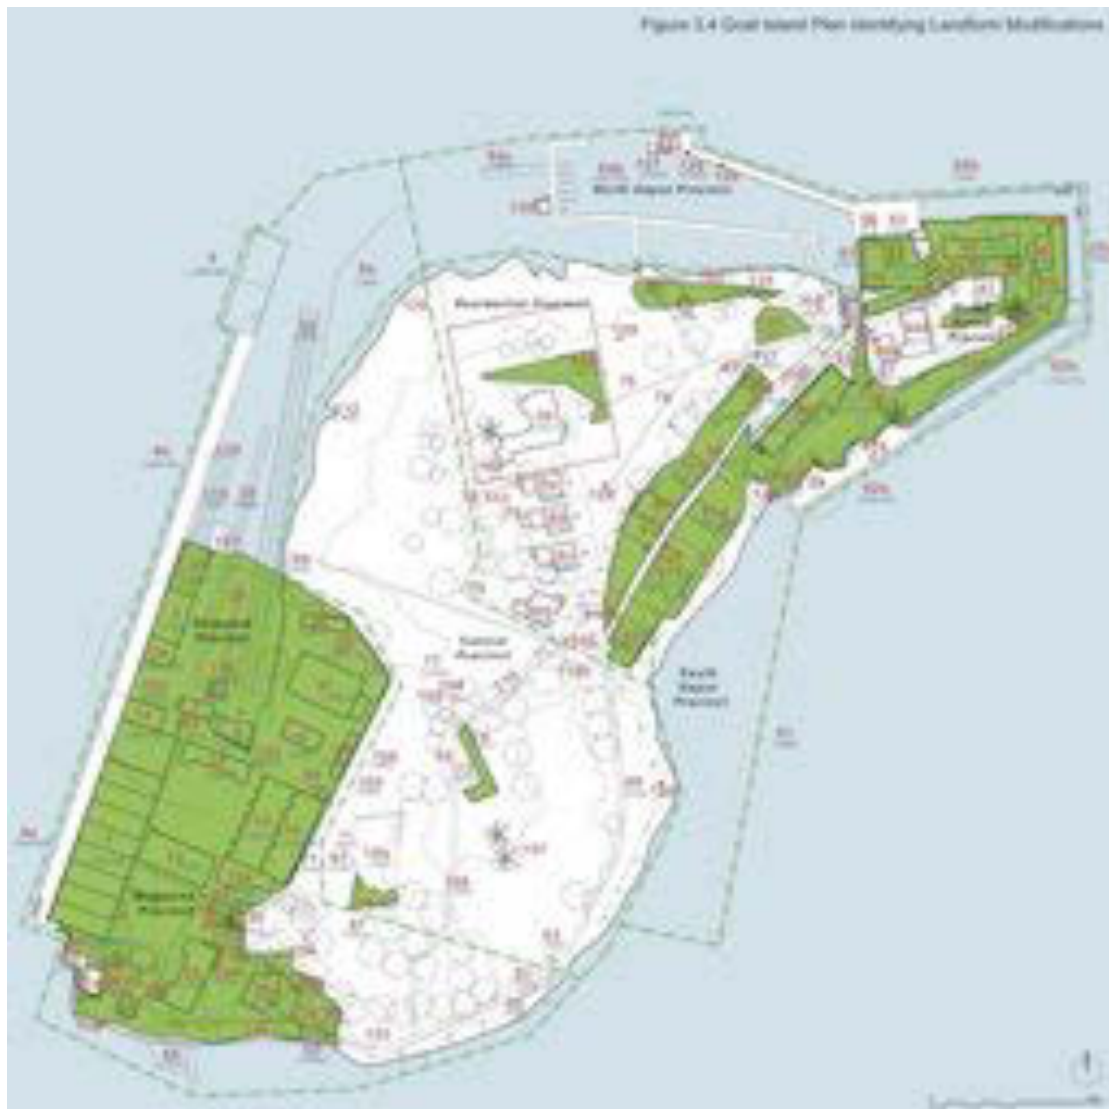
Figure 3.4 Plan of Goat island showing Areas of landform modification. The areas shaded green on the plan are the sections of the island that have undergone substantial landform modification through either quarrying and excavation and or fill including foreshore reclamation and cut and fill to create building platforms. Minor landform changes are not indicated. This plan is based on the 2007 aerial photograph and it is noted that sections of wharfs 4a, 4b, 5 and 51 and wharves 52b, 54c, 55a and 55b have collapsed and been removed.

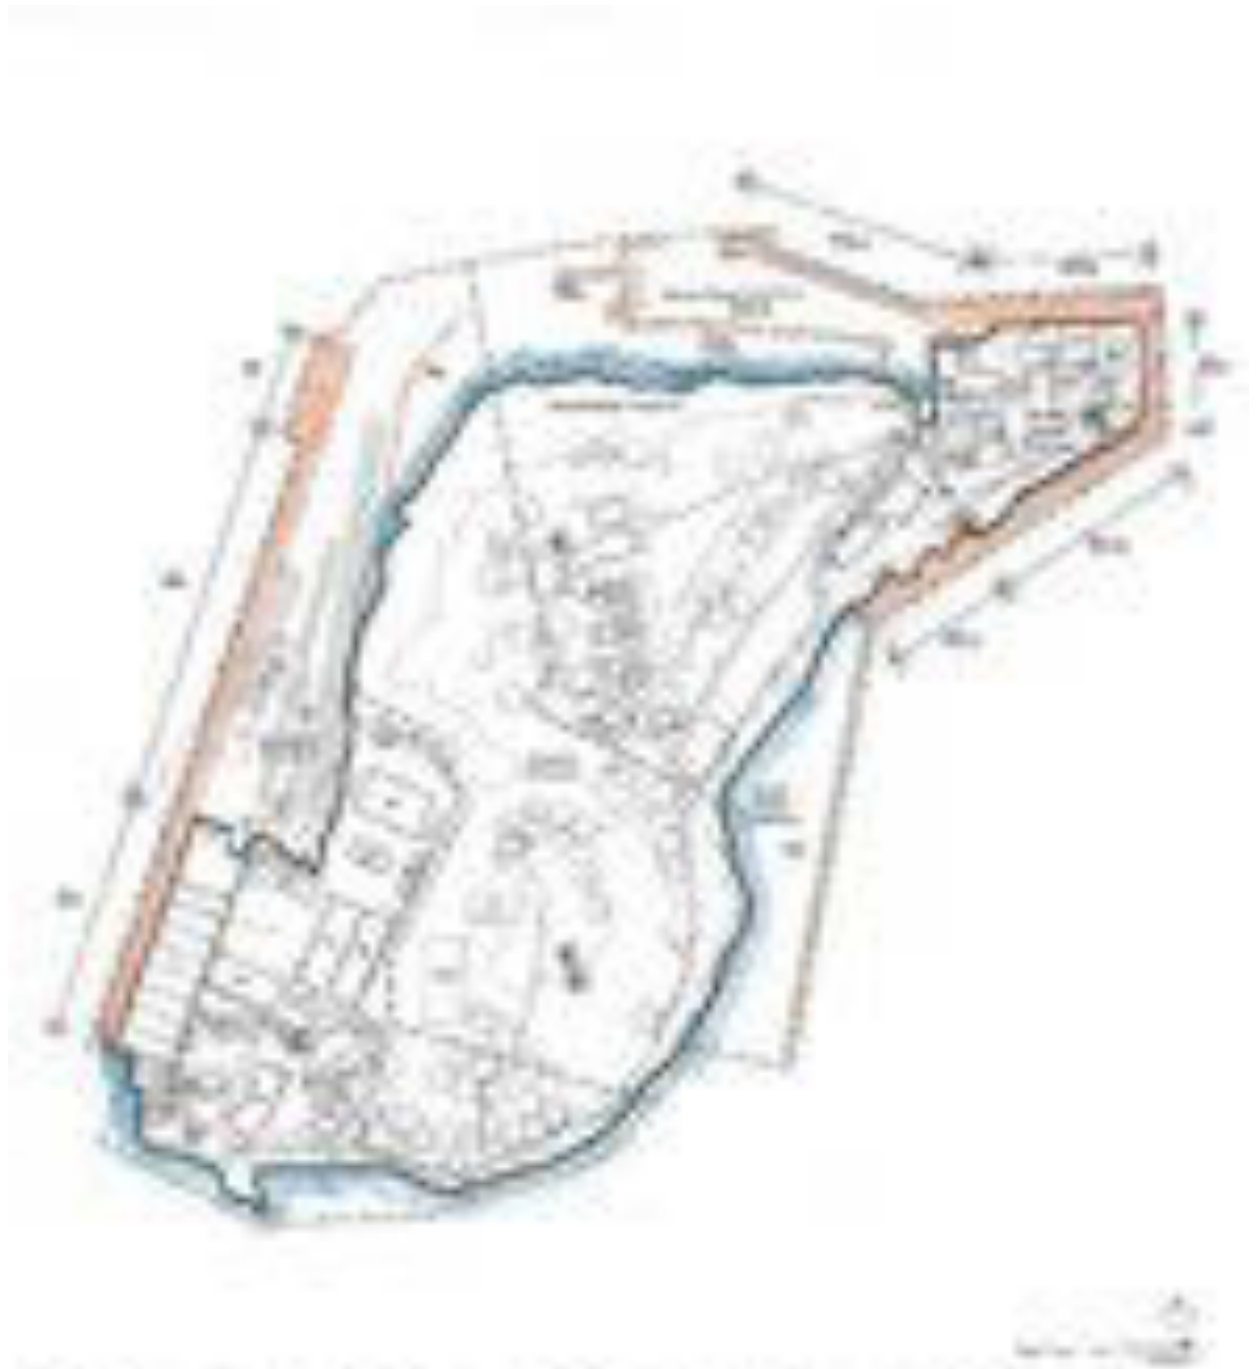
Item No	Date of construction	Description and Status
STONE JETTIES		
64	1835	Stone jetty - intact
66	1835	Stone jetty remains - ruin
97	1835	Stone jetty remains - within reclaimed area
98	1835	Stone jetty remains - within reclaimed area
TIMBER WHARVES AND PILES		
56	1941	Steps and walkway - steps collapsed
54b	1941-43	Boat Pens and walkways - intact
55a	1942	Northern broadside wharf - demolished 2008
55b	1942	Northern broadside wharf - demolished in part 2008, western end remains intact and repaired 2010
52a	1942-43	Eastern broadside wharf - poor condition
52b	1942-43	Eastern broadside wharf - demolished 2008
54a	1942-43	Ferry wharf and steps - poor condition
54a	1944	Ferry wharf extension - poor condition
4a	1946-1949	Shipyard broadside wharf - partially rebuilt
4b	1946-1949	Shipyard broadside wharf - poor condition, grids 32-37 collapsed. Wharf scheduled for removal.
5	1946	Coal bunker wharf – collapsed, piles remaining, scheduled for removal

5a	1963c	Line of fenders - intact
51	1969	Finger wharf - decking demolished 2009, steel piles remain

Figure 3.11 Site plan of Goat Island showing location and identification of wharf structures. Wharves that are assessed in this report are coloured orange and identified by existing numbering systems. Plan based on JS Kerr plan of Goat Island contained in the 1987 Goat Island Investigation.

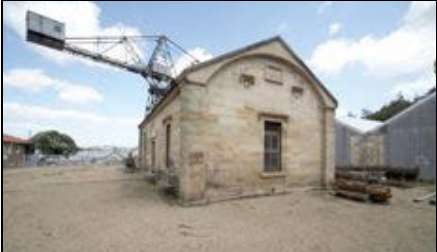
19*	1836	The Cooperage	Largely intact	Good/fair

<p>Originally the Cooperage the building was quickly adapted for other uses and has principally served a storage function over its life. It is constructed of coursed dressed stone blocks with small corner buttresses, stone gable ends and stone copings to the parapets. The roof is slate to match the magazine. The building has timber joinery windows and doors, a timber framed roof and floor. Symmetrically designed it was connected with covered ways that are since removed. A door to the rear elevation has been infilled. It is currently fitted out with storage racks as part of the shipyard use.</p>

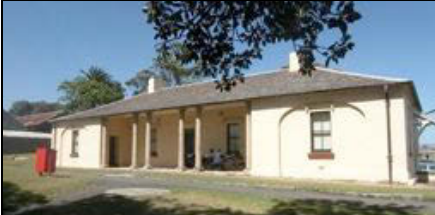
25*	1838	The Barracks	Largely intact, early form largely recovered in restoration works	Good/fair

Built as the barracks for the garrison it is of sandstone construction with a hipped slate roof and loggia supported on pairs of Ionic stone columns. The building underwent conversion in the late 1850s/60s to accommodate 16 men comprising a Foreman of Magazine, two labourers and a military detachment of 13 who had previously been housed in a 'barrack room' at the southeast end. Works included removal of the wall between the barrack room and Foremans Office (creating a larger living space for the detachment at the southern end of the structure), refurbishment of the central four rooms occupied by the Magazines Foreman which featured three chimneys, use of the northernmost two rooms to accommodate the two labourers. During 1924 the Sydney Harbour Trust converted the building into two residences with various timber additions and new openings in the walls, and removal of two internal walls. Much of this work was reversed by the Maritime Services Board in 1978, when the building was altered for museum use, returning it to its approximate 1850s form. SHT alterations which remain include the blocking up of the rear doorway that formerly connected to the kitchen beyond (which remains blocked), pressed metal ceilings and fireplaces added to the interior in 1924.

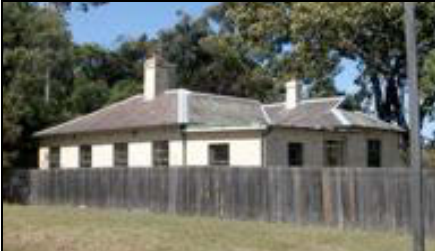
26*	1838, 1857, 1887	The former Barracks Kitchen, now known as the Kitchen Cottage	Extensively altered and extended	Fair

Originally a 2 room sandstone kitchen building located symmetrically behind the barracks building of sandstone with a hipped roof, it was converted and extended to 4 rooms in sandstone c1857 with a skillion roofed addition to the north side; again extended c1887 with rendered brick laundry/wc extension to northern end of west elevation; prior to 1924 the SHT undertook a rendered brick extension to the east and alterations to change use to a cottage; 1956 MSB sunroom extension and removal of sandstone walls to north.

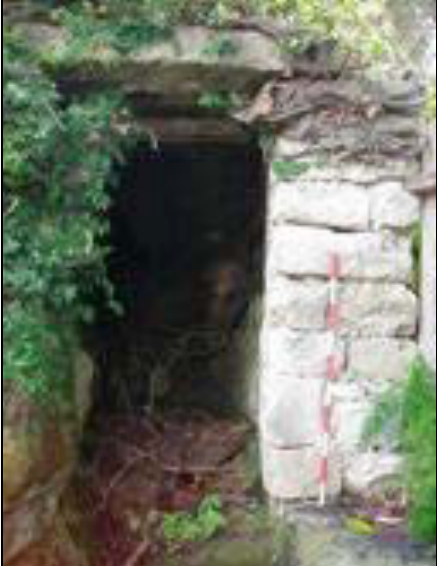
26a*	1838	Kitchen Cottage Alcove	Partially intact	Fair/poor

<p>At the rear of the kitchen is an alcove partially cut into the rock face on the western side and constructed of 8 courses of stone on the eastern side. The roof consists of at least 4 large lintel stones 150 mm thick x 1250 mm wide x 680 mm long. The interior has been painted or lined in the past and measures 2.4 m in depth x 1.9m in height. This may have acted as a food or wood store although it is particularly well constructed and in good condition.</p>		
61*	1836	Andersons couch	Intact	Good

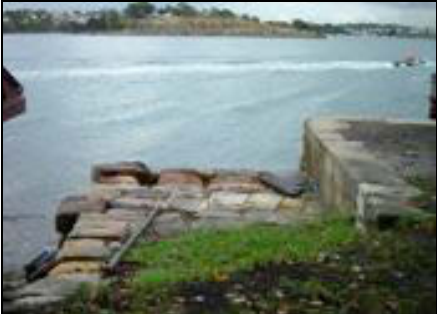
64*	1833c	Stone jetty	Largely intact but partially covered by later works	Fair/poor

<p>The first jetty was built of stone quarried from the island and completed in 1833 prior to the construction of the magazine. Remains of this are likely to be the oldest surviving built structure on the island. The jetty located at the western side of the island in front of the barracks and adjacent to the boat shed is in the same location as the original jetty but is likely to be rebuilt. It consists of at least four courses of massive ashlar blocks and a set of narrow stairs.</p> <p>The jetty was extensively modified in 1862 although the lower courses appear to be original. A more recent sandstone sea wall (1925) has been partially built over the northern edge of the jetty on a slightly different alignment.</p>

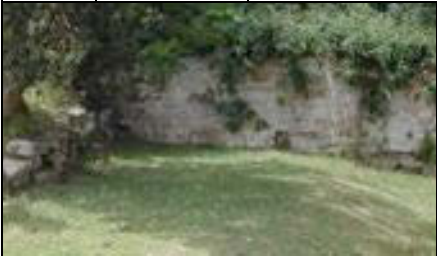
Item No	Date	Name	Level of intactness	Condition
70	1838	Magazine precinct Stone retaining walls	Largely intact	Good/fair

A series of coursed stone retaining walls behind the barracks and kitchen block to provide a levelled platform for the construction of these buildings. These walls are more rustic in construction than the fortified wall but are well laid and remain in sound condition.	
71*	1838	Fortified wall and sentry box	Largely intact	Good/poor

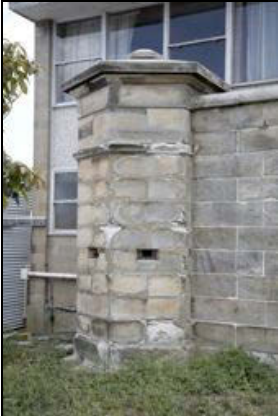
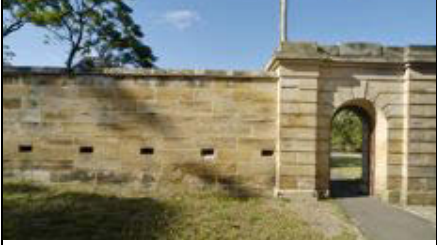
A coursed stone perimeter wall to the north, east and south of the magazine built on the edge of the quarry with a gateway, loop-holes and single sentry box on the southern alignment. The wall is finely dressed with even courses and the main gate is carefully detailed. The wall itself is plain coursed sandstone with a curved projecting coping. The wall is of considerable height at its western end and lower where it tops the quarry face. It is a compound wall rather than a blast wall (for security rather than for the containment of explosions), consistent with the standard British Imperial plans for early to mid 19 th century powder magazine complexes. However, the wall's construction by convicts in locally quarried sandstone gives it unique links to Goat Island and the early 19 th century history of the colony of NSW and of Sydney. British Imperial Infantry and artillery units sent to Goat Island on Garrison duty to guard the magazine between the 1830s and 1870 left a record of their presence by carving their regimental numbers on the sandstone sentry wall. The 'graffiti' records the almost continuous occupation by Imperial infantry regiments till 1870 and indicates which units spent time on the Island. The sentry box and a small section of wall to the immediate east of the sentry box appears to have been added to the wall slightly after the completion of the remainder of the wall and is of a different sandstone (possibly sandstone quarried from Barney's Cut in 1837-1838) (petrographic analysis by D. Young, 2007).

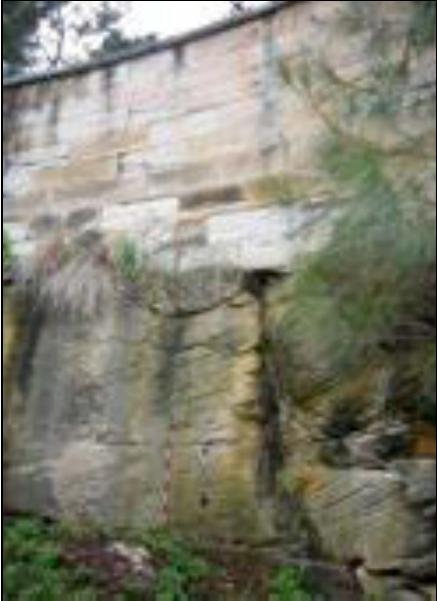
72*	1830s	Magazine precinct quarry face	Largely intact quarry faces remain	Good/fair

A quarried rock face up to approximately 7 m in height and related to the construction of the Queens Magazine, underlies almost the full extent of the Magazine Wall (no. 17). In 1833 ironed gangs were reported to be employed quarrying at the western end of the Island to level the ground and to provide stone for the magazine and a wharf. Apart from the obvious flat picked surface of the rock face, there is very little evidence of quarrying techniques. Several vertical and horizontal slots are cut into the rock face around the cooperage shed roof suggesting the roof may have been replaced. The Queens magazine and the cooperage are constructed from the same stone as that excavated from the magazine precinct quarry (Dr. R. Franklin.). The quarry produced high quality sandstone in substantial dimensions. A considerable amount of the stone was also cut for public building construction in Sydney. The large quarry into which the magazine complex was placed was cut by convicts to provide the stone for the buildings and the fill to create the edge of the levelled (or benched) platform on which the buildings are located. The quarry face remains largely in the form that it was cut with evidence of excavation, the quarry floor is up to a metre below the current ground level, allowing for foundation areas and drainage. It appears that the quarry has not been reworked or enlarged after the magazine was complete.

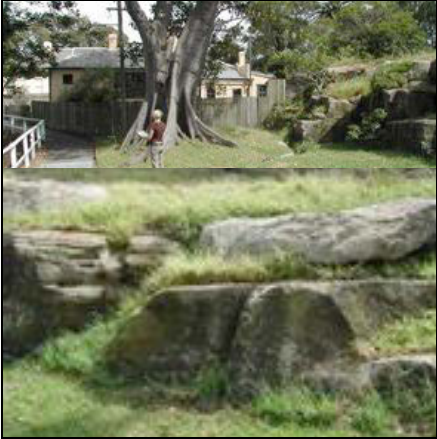
Located to the east of the kitchen building, the rock face that runs around the southern edge of the island is extensively quarried. Historic plans and documents locate privies and other out buildings in this position. The site consists of an 'L' shaped cut and several square and 'V' shaped channels likely to relate to the 1860s privy and drainage for the kitchen gardens above and to the north of the area, or simply as a source for quarried stone. Two courses of brick channeling that were identified in 1985, were not visible.

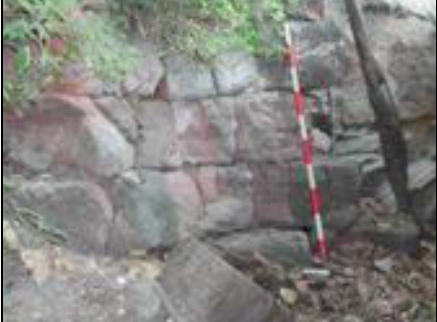
95	1830s	Remnant lime kiln	Archaeological site, kiln altered by later construction	Poor

In the rock face to the rear of the boatshed the partial remains of a circular stone structure consisting of 9 courses of ashlar stone 2.5m high which would have had a diameter of approximately 1.5m. The retaining wall to the north on which the fig tree is growing was constructed later and on a different alignment to the circular structure. The construction of the retaining wall or the boat shed may have resulted in the disassembly of the structure and incorporation of the stone elsewhere.

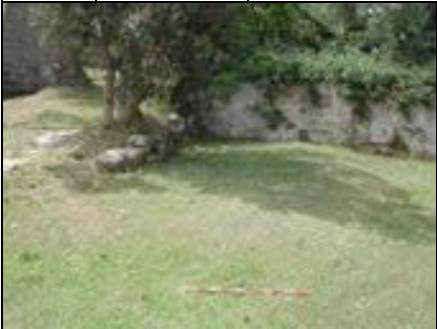
Adjacent and to the north of the barrack building a raised rectangular mound over which a later stone retaining wall is constructed. Gardens and a possible outbuilding were located here.	
115	1838c	Stone retaining wall and steps	Remains of pathway	Deteriorated

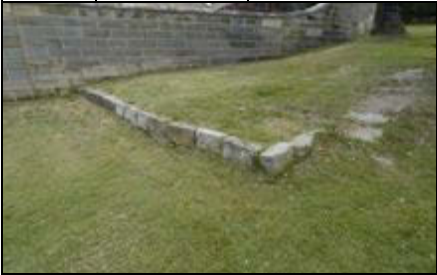
Between the barracks and the fortified wall a low stone wall and remnant steps indicating a path leading around the wall.	
119	1890s c	Foreshore fill site	Unknown	Eroding
		An area along the southern foreshore above the rock escarpment that has been filled to create a levelled platform around the colonial and later buildings. The extent of fill is not known however it can be partially ascertained by inspection of the eroding edge that has revealed fill and artifacts.

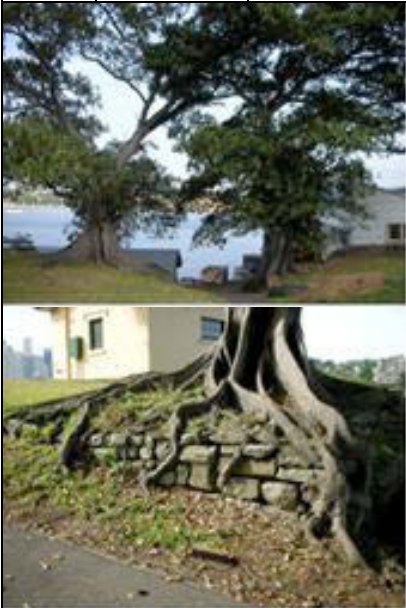
Item No	Date	Name	Level of intactness	Condition	
132	mid 1880s	2 Moreton Bay Fig Trees (<i>Ficus macrophylla</i>)	Mature	n/a

Two mature Moreton Bay Fig trees (<i>Ficus macrophylla</i>) remain either side of the ascending pathway near the southwestern slipway and appear to have been planted about the mid-1880s. Safety reports have been completed for the trees by Naturally Trees Arboricultural Consulting (Items 5 and 6) in 2005 and recommended actions carried out. The surface roots of the southern-most tree have enveloped a loose sandstone retaining wall such that, together, they form an interesting sculptural feature. The other tree has large areas of decay around its base and its southern buttresses have formed a wall along an old path alignment with the eastern-most root almost pointing the way to the Barracks front door. The trees have been a major feature of the southern side of the Island for about 100 years and represent one of the few tangible elements remaining on Goat Island of the late imperial period.

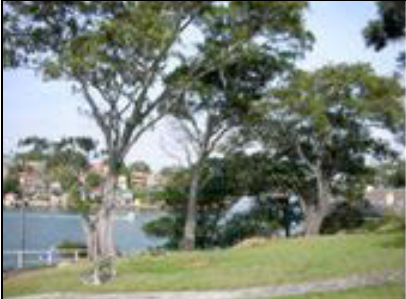
133	mid 1880s	2 Moreton Bay Fig Trees (<i>Ficus macrophylla</i>) and 1 <i>Ficus obliqua</i>	Mature	n/a

Line of three mature fig trees (2 x <i>Ficus macrophylla</i> and 1 x <i>F. obliqua</i>) to the east of the 1838 barracks mess. The form of these trees is different to the western fig trees as a result of numerous Coral Trees (now removed) in the vicinity forcing the fig trees to grow more vertically. As with the other fig trees these have been a major feature of the character of the southern shoreline for about 100 years and may have been part of a longer line of fig trees as there is photographic evidence of another fig tree to the west of the mess. The trees have been assessed by Naturally Trees Arboricultural Consulting (Items 19, 26 and 27) in 2005.		
134	1890s- 1910	Ombu (<i>Phytolacca dioica</i>)	Date unknown but probably late 19 th to early 20 th century planting

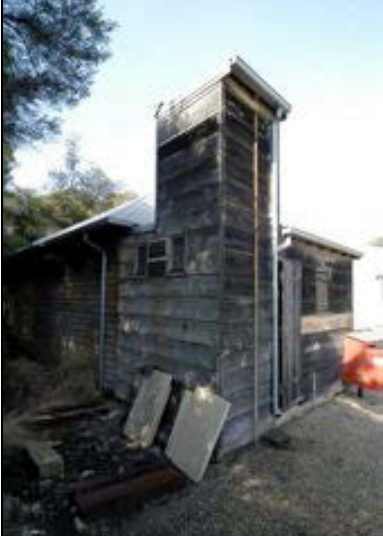
<p>This building is a weatherboard single storey building, with a "tower" at the south end (to house a water tank to supply water to the showers below). The building was built as an amenities building for the workers of the Shipyard. Workers would have a shower in the south lean-to addition and then go into the main area to get changed, where locker facilities were located. Hot water was gravity fed to the showers from a tank in the tower above the south addition. The larger room was a mess room. After 1948 when the new amenities building was constructed, the building was used for small fibreglass work.</p> <p>The building is a rectangular, single storey building of timber framed construction with weatherboard cladding. It has a hipped roof of corrugated iron. The building has lean-to weatherboard additions on either end with corrugated iron skillion roofs. A timber tower is located on the south addition. The building has timber framed double hung windows with horizontal glazing bars. There are small louvred windows in the lean to additions, located in the ends of the building. The southern wall has metal louvres. The doors are timber, framed and ledged.</p>

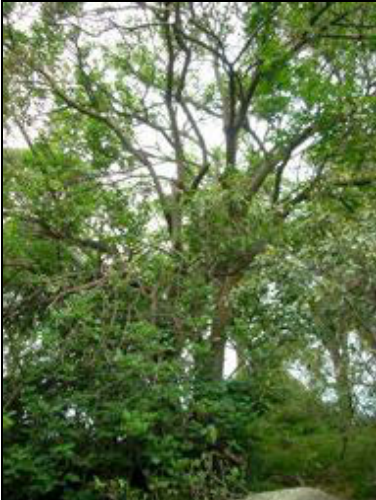
Once common around the southern part of the Island and around the Harbour Master's residence, only a few mature trees remain. The species is susceptible to major limb failure and can be a risk to public safety. It is also prodigious at self-propagation. The remaining mature trees are along the southern shoreline and it is likely that these were planted by the 1910s through the SHT. Other large trees are north of the Harbour Master's residence with younger plants spreading into other areas of the island (eg. east of upper central area).

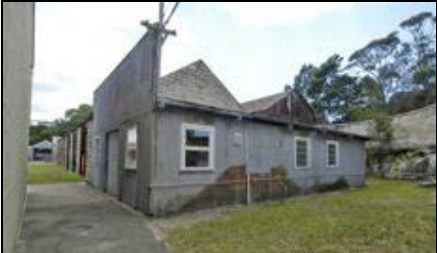
15a*	1942	Addition to Queen's Magazine	Largely intact	Fair/poor

A timber framed skillion roofed addition built on the end of the magazine as a store with a door cut through the end wall of the magazine to connect it. Like the workshop buildings it has a simple parapet to provide a squared front rather than reveal the skillion roof. It has no linings, is of very basic construction and is attached to the stonework of the magazine.		
23a*	1943	Boatshed	Reasonably intact, slipways removed, erosion to seafront	Fair/poor

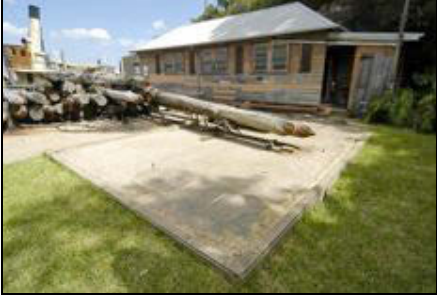
<p>A concrete slab that remains after demolition of an addition to the amenities building. The addition appears to date to the early 1960s and was a meal room attached to the change rooms. It had a garden behind which had a small fish pond that survives.</p>		
National Park Period				
-	-	-	-

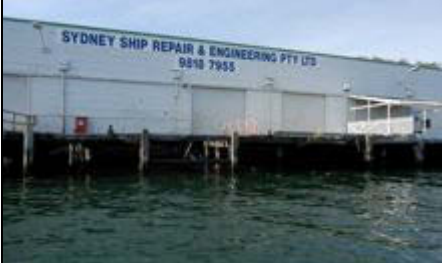
Maritime Period: MSB Phase				
1*	1946-1949	Ship Repair workshop	Reasonably intact, some alteration	Fair

A saw tooth roofed corrugated iron clad building with corrugated iron parapet to south, built from 1946-1949. Timber framing to south wall, timber framed windows with horizontal glazing bars, steel trusses to roof, and steel structural posts to interior, which are also used for equipment. Concrete floor. Rear (north) wall is concrete to lower section, with corrugated iron cladding and timber framed windows above. Corrugated iron clad timber partitions dividing the building's interior into bays. Built onto eastern end of the Broadside Wharf. Roller shutters to south (waterfront) wall.		
1a*	1962-3	Ship Repair Workshop addition	Reasonably intact	Fair

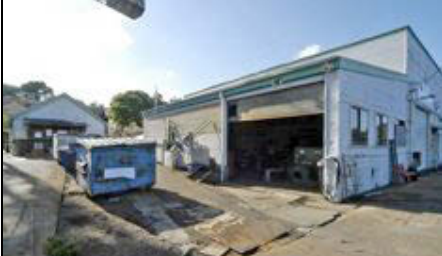
A simple skillion addition to the main workshop building of timber framing clad in corrugated iron. It has roller doors and was sited to avoid the rail system which closely abuts it.

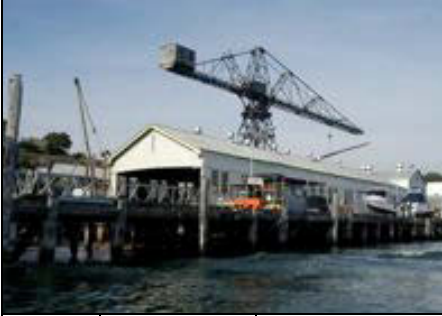
<p>The first section of this shed to be built was the southern section with a floor level located at wharf height and apparently built over the earlier slip rails. Originally with central timber columns, they were removed and a steel support structure added to provide for clear spanning. A small mezzanine is located at the south end.</p>	
2a*	Post 1945	Repair Workshop Addition	Reasonably intact	Fair

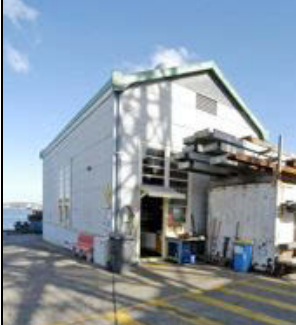
<p>A separate building built onto the end of the workshop building retaining the former external wall within the building. Used for stores its construction suggests the 1950s period but it does not appear on plans from the period.</p>	
3*	Post 1945	Slipway Workshop	Reasonably intact	Fair/poor

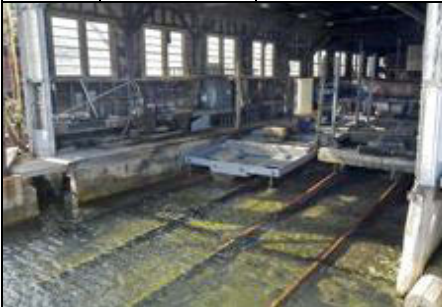
<p>An addition to the workshop building that provided cover over the upper part of the 1926 slipway for working on vessels, this is the only covered section of slipway. It is a timber framed building with timber trusses with a perimeter walkway.</p>

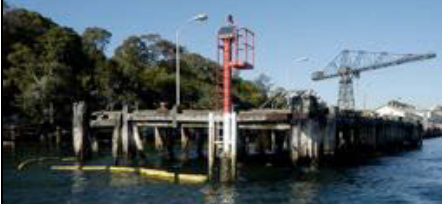
5*	1946	Coal loading Wharf	Partial collapse	Very poor

<p>Located at the end of the Broadside wharf, only the wharf structure remained from the former wharf and coal stage, the latter being removed as the wharf became unstable. It had the same construction as the adjacent wharves with the addition of a cluster of piles at the corner to protect the structure from shipping. It had a concrete deck through which the former superstructure framing extended, this was all removed to deck level. The superstructure required bracing and inclined structural members survive in part immediately below the deck level. The wharf was used to hold coal reserves in timber framed and lined bins for fueling vessels used by the MSB. The structure is in very poor condition with most piles failed and the decking has collapsed leaving only a small number of piles. Access is not available due to its condition.</p>

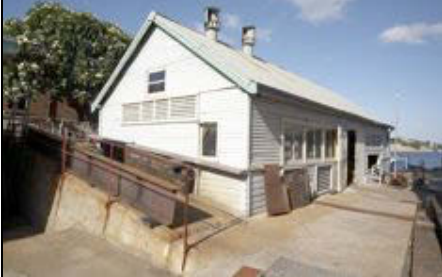
Item No	Date	Name	Level of intactness	Condition
7	1949	Winch House	Reasonably intact	Fair

<p>The corrugated iron clad and timber framed shed housing the winch mechanism for the 1949 slip and a stores area. It is gabled roof.</p>	
8	1965	Winch House 500 ton	Reasonably intact	Fair

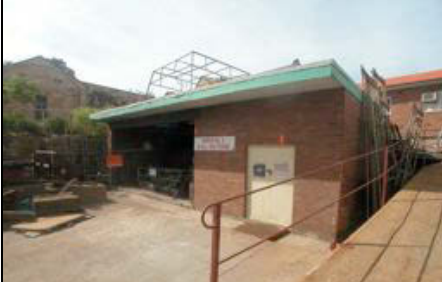
<p>A utilitarian brick shed with open section housing the winch and a secure area housing the winch motor. The shed has a flat roof. Built in conjunction with the 500 ton slip, it accommodates the winch mechanism.</p>	
9*	1963	Hammerhead Crane	Not operational	Fair/poor

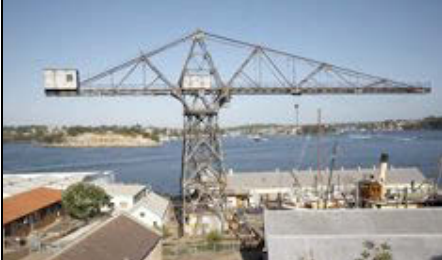
<p>The Hammerhead Crane is a large, visually dominating, industrial landmark on Goat Island. Built in 1924 in Glasgow, Scotland, it was originally sited at Mort's Dock at Balmain before re-erection by the MSB at Goat Island in 1963. It has been in use until late 2010 but is no longer operational. The crane is currently being assessed to determine future actions.</p>

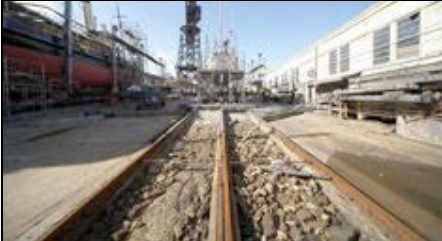
29*	1949	150 ton slipway	Reasonably intact	Fair

<p>The 150 ton slipway retains its original formation near the water with the use of timber logs to support the rails and stone infill, the higher levels have been upgraded with concrete construction.</p>	
30*	1965	500 ton slipway	Reasonably intact	Good

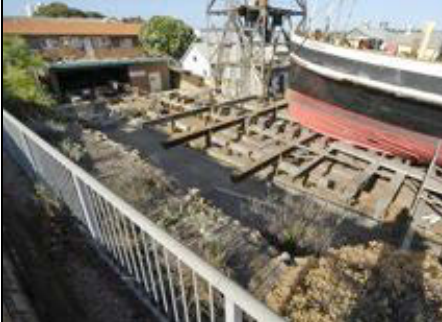
<p>The 500 ton slipway required further excavation of the cliff edge and the magazine area to accommodate the rails, overhang and the winch house. This was the last major work to be undertaken in the shipyard.</p>

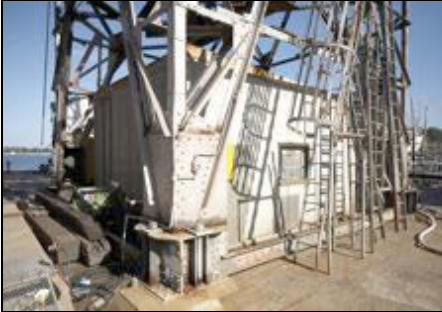
Item No	Date	Name	Level of intactness	Condition
114	1963c	Shed	Reasonably intact	Fair/poor

<p>A simple steel clad shed built within the frame of the hammerhead crane probably around the same time as the crane was installed.</p>	
120	1945c	Jib crane	Condition unknown	Assumed poor

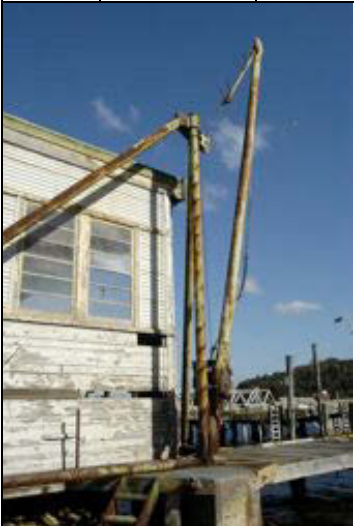
<p>A jib crane with braces located on a small section of wharf near the repair workshop. The crane appears to date from the 1945 period.</p>

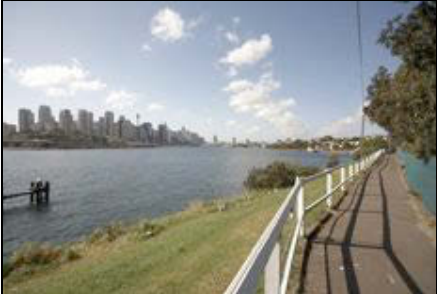
Item No	Date	Name	Level of intactness	Condition
69*	1836+	Magazine Walk	Alignment intact, later changes to finishes and levels	Good

This section of Magazine Walk is located between rocky outcrops and runs along the edge of the escarpment. It was separated by a white fence that has been replaced with an inappropriately designed but OH+S compliant fence. The route provides views to the city.		
77	1836c	Evidence of quarrying on the edges of the ridge	Visible but difficult to access	n/a

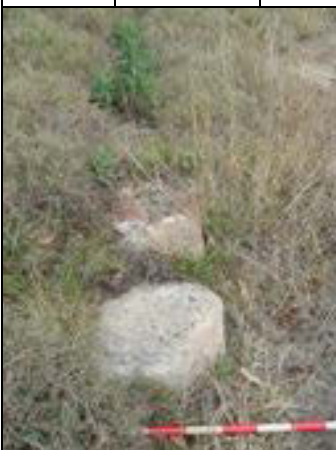
Sandstone footings directly adjacent to and west of the tennis court. The site is overgrown and the footings are aligned in such a way that they veer towards the tennis court. View south.		
93*	1830s	Artefact scatter	Archaeological site	n/a

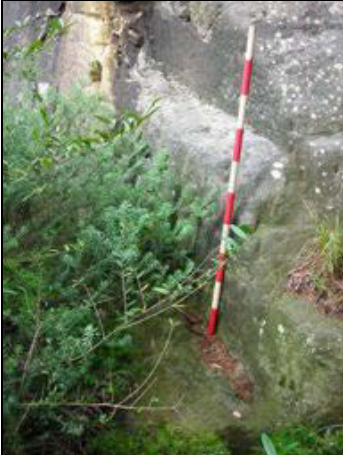
Item No	Date	Name	Level of intactness	Condition
110c	1840s c	Rock cut	Archaeological site	n/a

Function unknown. Likely evidence of early quarrying or related to a structure, now removed. Visual inspection limited due to vegetation overgrowth.	
112	1836	Quarry face	Archaeological site along cliff edge	Fair

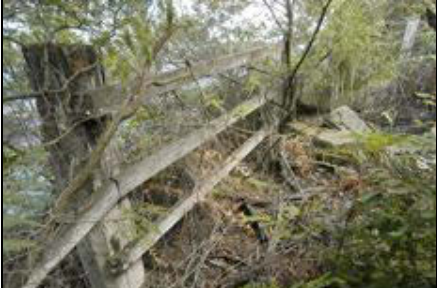
Remains of the former access path linking the shipyard to the residential precinct. Extending along the edge of the cut for the slipway and originally accessed from a timber stair at the base, it had a concrete kerb, stone steps (now dislodged) timber rails along the cliff edge and extended to the rear of the residences. It is now overgrown and difficult to access.

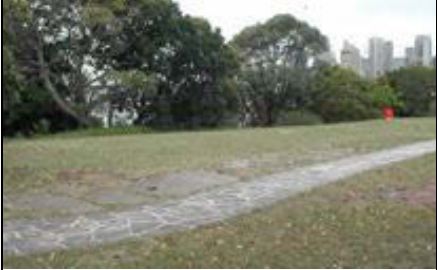
73	1941	Recreation hall archaeological site	Archaeological site, footings remain visible	Fair

The remains of the Recreation hall (17.08m x 7.9m) are located on the highest point of the island's ridgeline, between the tennis court and the rear of the cottages. Named 'Victory Hall', it was constructed in 1941 around the same time as the swimming pool and the tennis court in order to foster community spirit and provide entertainment for the 26 men and a number of family members living on the Island. Constructed of wood on brick footings with an iron roof, the building was considered handsome and could accommodate 250 persons. The building was rectangular in shape with small additions to the rear. The Hall was rebuilt after fire damage and demolished in 1960. Dry pressed double brick foundations, evidence of ancillary buildings and associated pathways still survive.	
74	1937c	Stone retaining walls creating platforms	Largely intact with some failure of loose laid walls	Fair/poor

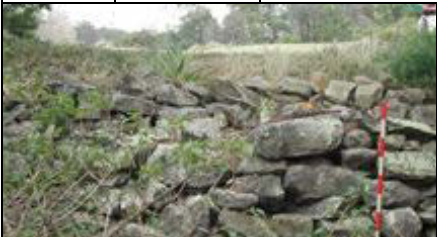
A series of low dry stone walls built from stone collected on the island and presumably from part of the quarrying activity used to bench the site to create leveled areas for recreational use. The illustration is the wall below the tennis court, other walls created a leveled area on the ridge line for the recreation hall building.	
103	1943	Seat on the ridge line	Intact	Good

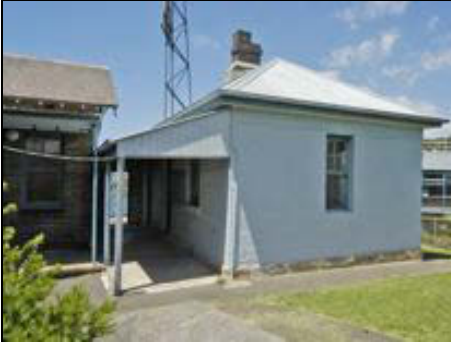
Item No	Date	Name	Level of intactness	Condition
Pre-Contact Period				
-	-	-	-	-
Colonial Period				
46a*	1865	Cottage (aka Artillery Sergeant's cottage)	Altered but reasonably intact externally	Fair

<p>A sandstone two-room building with a hipped roof and central chimney, associated with cartridge laboratory use of the Former Water Police Station, the cottage was built as accommodation for a Sergeant of Artillery. From 1912 when the adjacent Fire Brigade Barracks (46b) was built, the cottage was used as a Fire Brigade mess room. From 1963 the cottage was used as a wet-weather gear store for MSB Dredge staff (south room) and as a paint shop (north room). This involved installation of a pipe partition and coat racks to the south room (still evident). The north room appears to have later been used as a tea room for MSB staff (see kitchen fitout). The roof is now clad with corrugated iron (replacing slate) and the building's exterior has been painted over the sandstone. The verandah to the east elevation appears to be an early Sydney Harbour Trust addition, and does not appear on the 1891 survey of the Island. There are areas of archaeological potential in the vicinity of the cottage, being the sites of earlier structures including former additions, laundry and privy.</p>

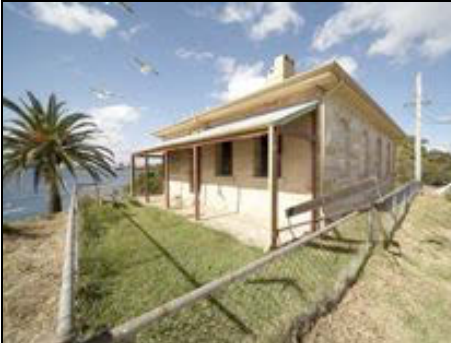
47*	1838	Water Police Station	Reasonably intact, additions removed	Fair/poor

<p>An ashlar sandstone walled Water Police Station designed by Government Architect Mortimer Lewis to an adapted design from Loudon's "Villa and Cottage Architecture". It was altered in 1865 after eviction of the Water Police for conversion to a cartridge laboratory. From evidence in documentary sources, the verandah to the east elevation appears to have been added during the 1880s. The building had a range of later alterations for SHT use, including the weatherboard addition remaining on the south elevation.</p> <p>The building has a hipped roof clad in slate, a simple front verandah and blind windows to complete the symmetry of the design. The side windows are set in arched recesses. Much of the joinery has been replaced. The building is unoccupied and requires considerable conservation work.</p>	
86*	1837	Barney's Cut	Reasonably intact but partially infilled	Good/fair

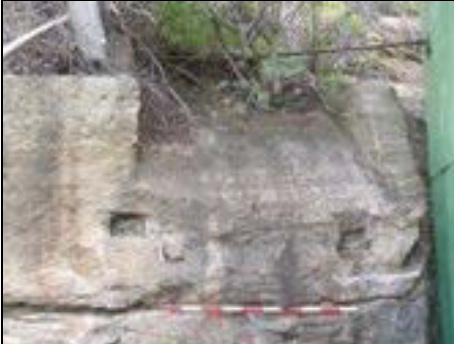
100	nd	Remains of timber stair	Archaeological site, remnant elements remain	Poor

Remains of the stairs leading down from the Water police precinct to the wharf/jetty constructed in 1836 on the northern side of the Island. Photographic evidence shows the wooden hand rail and stairs still in place in 1945. Only 4 rectangular slots for rails now remain cut into the rock face and a cut 1m wide ramp where the wooden stairs were likely to be located. View south.

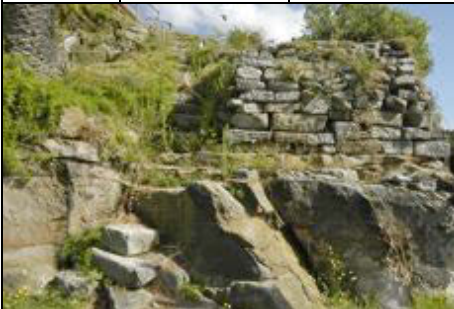
Item No	Date	Name	Level of intactness	Condition
101	nd	Stone steps and walls	Archaeological site, remnant elements remain	Poor

An early set of stone steps, probably dating from the time of construction of the water police station leading down to the point. The edge of the escarpment has been built up with dry stone walling to retain the upper level area in front of the building. The lower edge of the photo shows further excavation.	
Maritime Period: Sydney Harbour Trust Phase				
46b*	1912	Barracks	Altered but reasonably intact	Fair

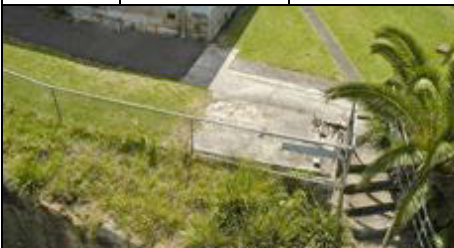
126	Post 1912	Amenities slab	Archaeological site	Ruin

The remains of a former outbuilding described as an amenities building with evidence of toilets and drainage extant. This location has been occupied with a structure of some form from the Trust period, although the exact nature of the building is not known. This is one of the few remaining visible slabs of buildings that were located throughout the area.	
138	SHT phase	Canary Island Date Palm (Phoenix canariensis)	Mature

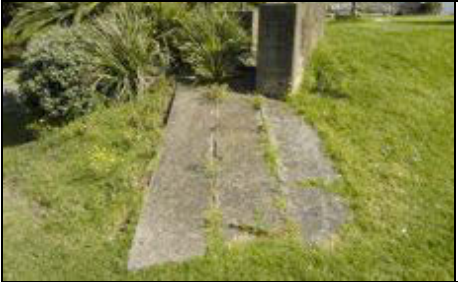
<p>Remains of concrete path extending from buildings to the waters edge, originally two strips and later infilled. A navigation marker has been constructed on the path and undergrowth has encroached.</p>

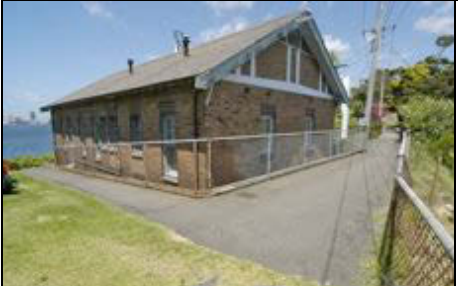
<p>Fencing surrounds the precinct and now comprises low steel tube framing with steel mesh infill. The fencing now principally protects the escarpment edge and the moat around the barracks, earlier fencing in the area, which appears to be timber picket was used to define yards, the access path and service areas.</p>	
129	1970s-1980s	Maritime markers	Intact	Good/fair

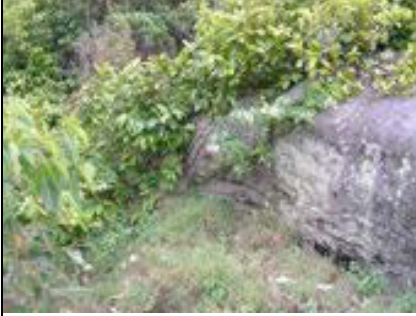
Item No	Date	Name	Level of intactness	Condition
Pre-Contact Period				
62*		Shell midden	reasonably intact, covered by grasses	Fair

<p>The shell midden was not visible during the survey conducted for this report. It was identified in 1985 but is now overgrown and has not been visible since.</p> <p>A small shell midden was located by Rich (1985) on a rock platform on the north eastern side of the island, in the forecourt of the residential precinct. According to the report, it measures 1200 mm x 400 mm and 150 mm deep and consisted of predominantly (c.75%) <i>Anadara trapezia</i>, or cockle, the remainder being made up of Hairy Mussel and a small number of inedible univalves. The deposit did not contain charcoal, bone, or stone artefacts and was considered to be highly disturbed, 'mixed around' and no part of the deposit was considered to be in situ (Rich 1985). Given the inedible nature of some of the shellfish species, the lack of artefacts and other food remnants as well as its proximity to the nearby buildings, a question as to the identification of this feature is raised, however the midden may also be exceptionally old.</p>

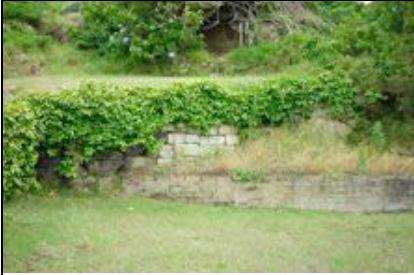
Site of first dynamite store built in 1875, just to the west of the cut. The building was later the site of a Sydney Harbour Trust cottage, later demolished and there are only ephemeral remains of a building platform surviving. The magazine was originally a wooden structure with an iron roof. Documentary evidence indicates the former magazine functioned as a Sydney Harbour Trust residence 1901-1913, when it was vacated. Documentary evidence implies the building may have been converted to a weatherboard and tile residence in 1913, however on 1920s survey plans the 1913 Sydney Harbour Trust residence in this location has both a different footprint and different orientation to the 1875 magazine.

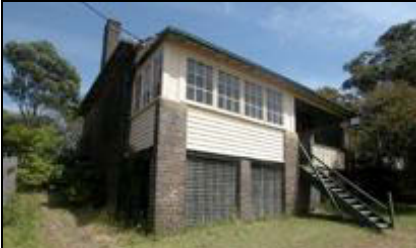
38b*	1916	Cottage No 2	Reasonably intact	Poor

<p>See 38a for general description.</p> <p>Features 4 panel interior doors, ceiling roses, no cornices to ceilings, picture rails, carpeted floors to front rooms. Front verandah partially enclosed with weatherboard and windows.</p>		
38c*	1916	Cottage No 3	Reasonably intact	Poor

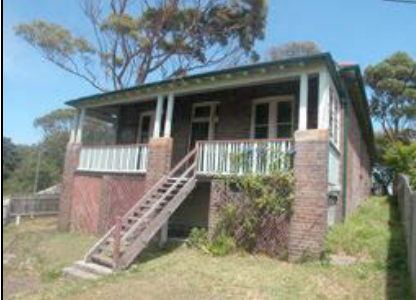
<p>See 38a for general description.</p> <p>Interior doors are timber 4-panel. Features plaster skirting boards, picture rails. Masonite ceiling to lounge room installed below original fibrous plaster ceiling. Rear weatherboard addition. This is the cottage in the worst repair, having been unoccupied for some time.</p>		
38d*	1922	Cottage No 4	Reasonably intact	Fair

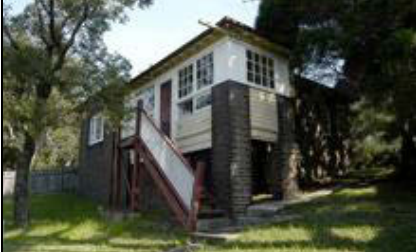
<p>A Former Fire Brigade face brick cottage built 1922 to a different design to the earlier remaining cottages reflecting the change in styles from federation to interwar periods, with hipped roof and unglazed terracotta tile roof. The cottage is elevated on brick piers and has extensive views to the harbour to the east. The front verandah on the northeast end of the front (east) elevation has been enclosed. Windows are timber-framed multi-paned double-hung. The timber front steps are deteriorated.</p>

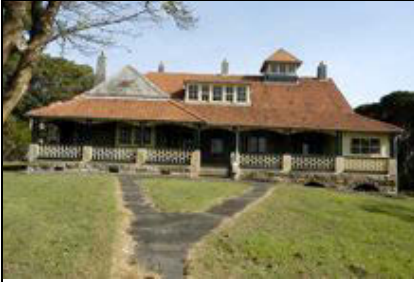
Item No	Date	Name	Level of intactness	Condition	
39*	1901	Harbour Master's Residence	Reasonably intact	Fair/poor

The Harbour Masters Residence is a substantial face brick, asymmetrical residence with a complex hipped and gabled unglazed terracotta tile roof featuring an east-facing eyelid dormer, roughcast stuccoed gablet, prominent viewing tower roofed in unglazed terracotta shingles and four tapered roughcast stuccoed chimneys. The residence is Federation Bungalow style, with some Federation Arts & Crafts detailing (use of roughcast stucco, tapered chimneys). The principal elevation of the residence has extensive views east to the main harbour. The ground floor exterior features a return verandah with timber balustrade to the main east elevation and part of the north and south elevations. French doors open onto the verandah. The ground floor accommodates 7 main rooms, plus servant's quarters, kitchen and laundry to the rear (west) with south facing (now enclosed) verandah, plus bathrooms, halls, pantry and storage rooms. The large roof form contains a first floor level with two bedrooms and a stair hall, including stairs to the viewing tower. The square, hipped roofed viewing tower has multipaned casement windows on all four elevations. All major interior rooms to the ground floor feature marble surrounds to fireplaces, minor bedrooms (except to first floor where fireplaces have been removed) have timber surrounds to fireplaces. Ceilings are plaster on metal lath, generally with ceiling roses. Interior doors are timber 4-panel except where replaced with modern flush doors.

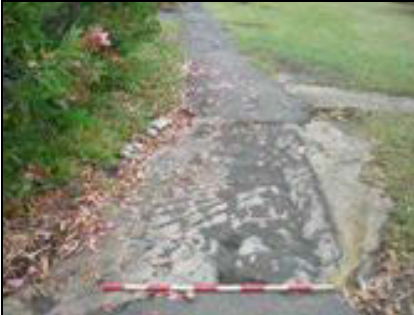
76	1903+	Paths	Largely intact	Good/fair

A number of paths have been cut into bedrock and in some cases, such as the path leading to the Harbour Masters Residence, have been asphalted.		
78	1916+	Fencing to rear yards	Intact but in poor condition	Fair/poor

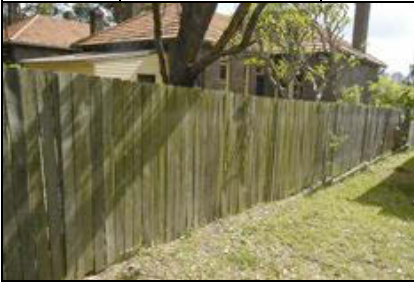
Paling fences, replaced over time, remain in location around the four fire brigade residences similar to fencing around the precinct from its first construction.		
79	1908	Reservoir	Ruin	Fair

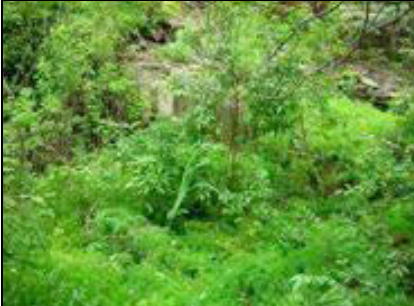
Located on the north of the island near the ferry wharf (former fresh water service wharf) the remains of the 20,000 gallon (90,000 liter) circular water reservoir constructed in 1908 is highly overgrown and appears to be in a poor condition. The remains stand no higher than 1 m with a circumference of 6.65 m and constructed of sandstone with a concrete skin, which is delaminating. Water was brought from the mainland and stored here for the use of the occupants. Iron tanks were also used on the island to service the cottages.

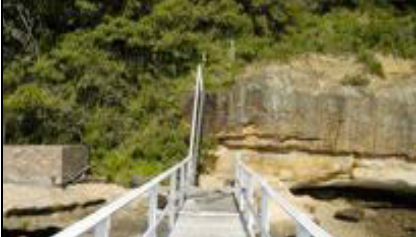
Item No	Date	Name	Level of intactness	Condition
80	1903-1905	Timber stairs to waterfront	Collapsed	Ruin

<p>The stair dates from around 1901 and the lower walkway (item 54b) from 1941 although it is probable that it has all been reconstructed. The stair has collapsed and the end of the walkway is in poor condition. It was the first connection to the wharf for the new harbour master's residence and connects to a series of paths on the cliff top.</p>	
81a*	1875/1916	Site of residence	Archaeological site	Fair

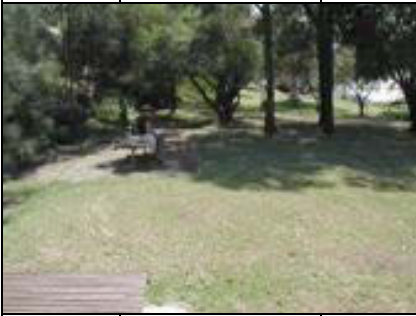
<p>The site of the former duplex constructed in 1913 is the most indicative of all the residential sites. The area has been terraced and a stone retaining wall faces the path on the northern side. Concrete stairs lead up to the building platform which retains the concrete front veranda and evidence of the wooden railing at the front.</p> <p>At the rear, the green painted concrete remains of the laundry floor are visible as well as several slots and cuts in the quarried rock face and iron attachments suggesting the position of a lean-to outbuilding.</p>	
81c*	1913-15	Sites of residence	Archaeological site	Fair

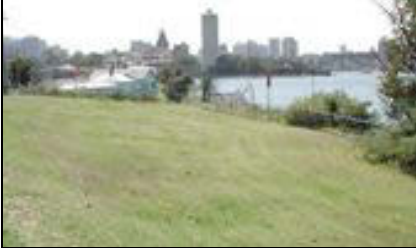
Item No	Date	Name	Level of intactness	Condition
81e*	1901-03	Sites of residence	Archaeological site	Fair

A modified grassed area with dips and humps on the southern side of the path. The land form slopes down to the water and the former weatherboard and tile building may have been supported by piers on the southern side. Demolished in 1970, no structural remains from the cottage are visible.		
81f*	1913-15	Sites of residence	Archaeological site	Fair

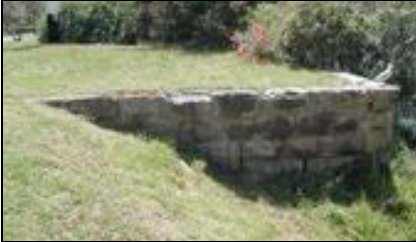
A modified flat grassed area on the southern side of the path for a cottage that was constructed of wood with brick and concrete footings in 1913. A concrete slab remains between the site of the house and the path and up to 5 courses of stone form a retaining wall at the front (south) of the house.		
99	1916+	Gardens and garden features	Varied intactness	Generally poor

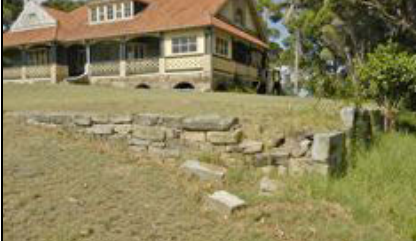
102	1901	Benching of lawn areas	Largely intact	Fair

The area around the harbour masters house was benched with the construction of a low drystone retaining wall including steps to the northern lower lawn area. The whole area was fenced early in its use but there is no remaining evidence of fencing. The level change is minor but clearly defines the extensive garden and lawn area around the house.
